**Flood Control Project Maintenance  
Levee Inspections**

**Maintenance Issue Types Only, Levee Inspection Report By Mile - Fall 2014**

**Reclamation District No. 0150 Merrit Island**

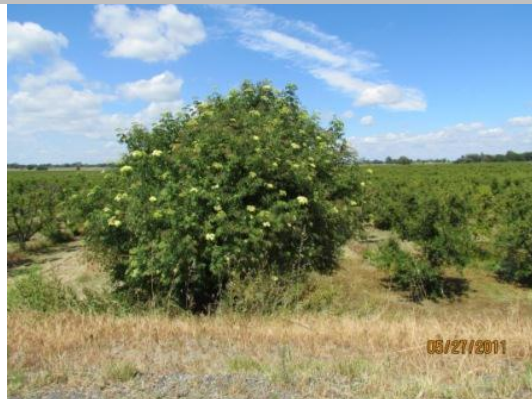
Photo 1 of 1 : FA\_2014\_RD0150\_15\_3\_20141021\_00003.jpg

LM Start	0.20	Rating **	A/W	Issue No.	3
LM End	0.20	Issue Type +	Ma	Location *	LS
Category	Earthen Levee			GPS Latitude/Longitude	
				Start	End
Item	Vegetation			38.331402 °	38.331402 °
				-121.580358 °	-121.580358 °
DWR ID	DWR_RD0150_01_s_2012_3				
Action/Comments					
Elderberries are blocking visibility and flood fight capability.

Elderberry bush was found on the landside of the levee. The picture was taken from the crown looking downstream.

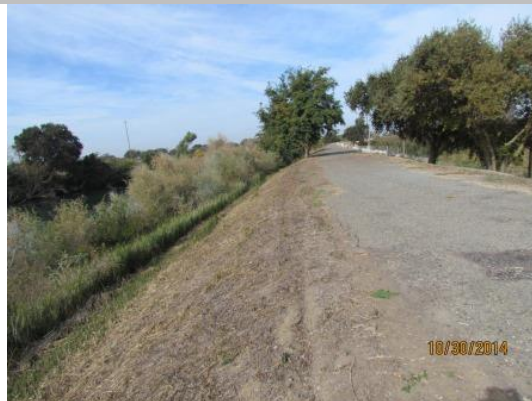
Photo 1 of 1 : FA\_2014\_RD0150\_15\_1\_20141104\_00004.jpg

LM Start	0.25	Rating **	A	Issue No.	1
LM End	0.51	Issue Type +	Ma	Location *	WS
Category	Earthen Levee			GPS Latitude/Longitude	
				Start	End
Item	Vegetation			38.330903 °	38.328212 °
				-121.579848 °	-121.576708 °
DWR ID	DWR_RD0150_01_f_2014_1				
Action/Comments					
Control annual grass and weeds on the levee slopes and easements.

View of the waterside slope of the levee looking upstream.

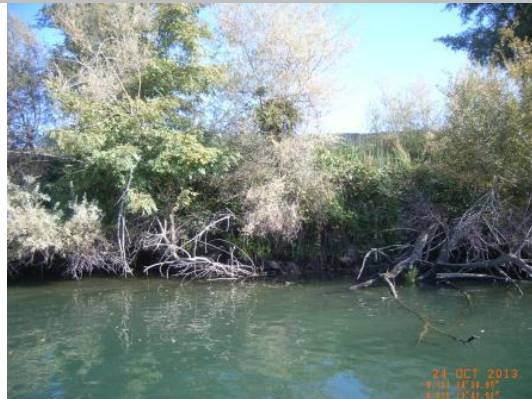
Photo 1 of 2 : FA\_2014\_RD0150\_15\_2\_20141021\_00001.jpg

LM Start	0.44	Rating **	M	Issue No.	2
LM End	0.49	Issue Type +	Ma	Location *	WS
Category	Supplemental			GPS Latitude/Longitude	
				Start	End
Item	USACE Erosion Survey			38.328091 °	38.328606 °
				-121.576640 °	-121.577472 °
DWR ID	DWR_RD0150_01_f_2014_2				
Action/Comments					
Inspector Comments: 2013: Old toe repair unraveling. Bridge at upstream end of site. [2013 Site ID: STR_28-4_R]

USACE 2013 Photo #1

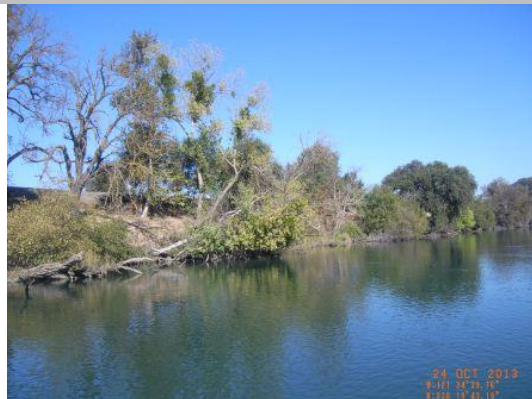
Photo 2 of 2 : FA\_2014\_RD0150\_15\_2\_20141021\_00002.jpg

LM Start	0.44	Rating **	M	Issue No.	2 (cont)
LM End	0.49	Issue Type +	Ma	Location *	WS
Category	Supplemental			GPS Latitude/Longitude	
				Start	End
Item	USACE Erosion Survey			38.328091 °	38.328606 °
				-121.576640 °	-121.577472 °
DWR ID	DWR_RD0150_01_f_2014_2				
Action/Comments					
Inspector Comments: 2013: Old toe repair unraveling. Bridge at upstream end of site. [2013 Site ID: STR_28-4_R]

USACE 2013 Photo #2

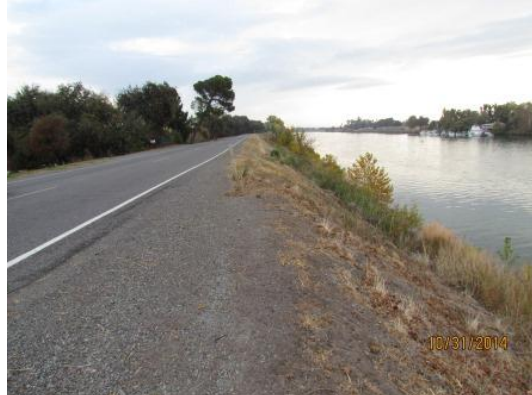
Photo 1 of 1 : FA\_2014\_RD0150\_16\_47\_20141104\_00071.jpg

View of the waterside slope of the levee looking upstream.

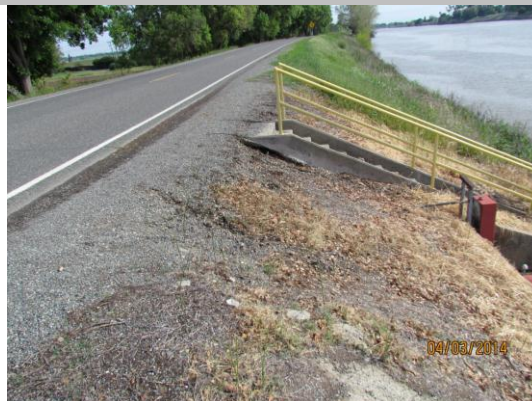
Photo 1 of 2 : FA\_2014\_RD0150\_16\_6\_20141021\_00002.jpg

LM Start	0.40	Rating **	M	Issue No.	6
LM End	0.40	Issue Type +	Ma	Location *	WS
Category	Earthen Levee			GPS Latitude/Longitude	
				Start	End
Item	Slope Stability			38.332717 °	38.332717 °
				-121.572083 °	-121.572083 °
DWR ID	DWR_RD0150_02_s_2012_6				
Action/Comments					
Repair the levee slope damaged by foot traffic and prevent access where possible.

Updated photo of the slope instability on the waterside of the levee looking upstream during spring 2014 inspection.

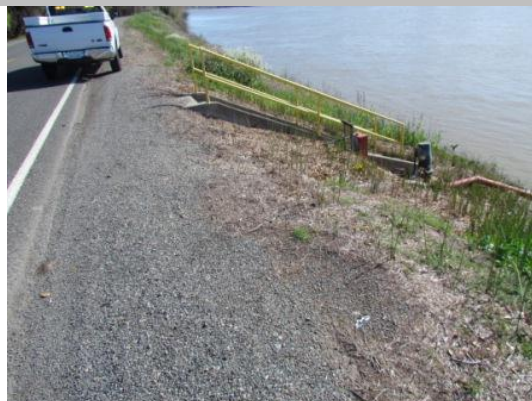
Photo 2 of 2 : FA\_2014\_RD0150\_16\_6\_20141021\_00003.jpg

Slope instability was found on the waterside of the levee looking upstream.

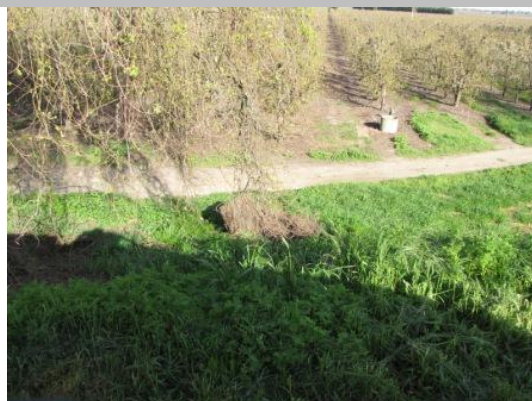
Photo 1 of 1 : FA\_2014\_RD0150\_16\_14\_20141021\_00009.jpg

View of a tree stump on the landward slope.

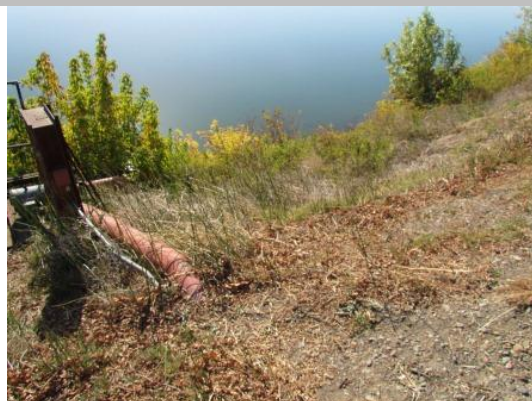
Photo 1 of 6 : FA\_2014\_RD0150\_16\_961\_20141021\_00047.jpg

LM Start	3.29	Rating **	M	Issue No.	961
LM End	3.29	Issue Type +	Ma	Location *	WS
Category	Earthen Levee			GPS Latitude/Longitude	
				Start	End
Item	Erosion / Bank Caving			38.355321 °	38.355321 °
				-121.530902 °	-121.530902 °
DWR ID	DWR_RD0150_02_s_2012_961				
Action/Comments					
Schedule repair of erosion site prior to the next inspection. Inspector Comments: Depressions into the waterward slope can be seen along the waterward slope at this site. Also note the damaged pump support, pump, and pipe just upstream of the site; they may contribute to the erosion in a high water event and should be removed.

View of the erosion on the waterside slope of the levee near the pipe looking downstream. This picture was taken during the fall 2013 inspection.

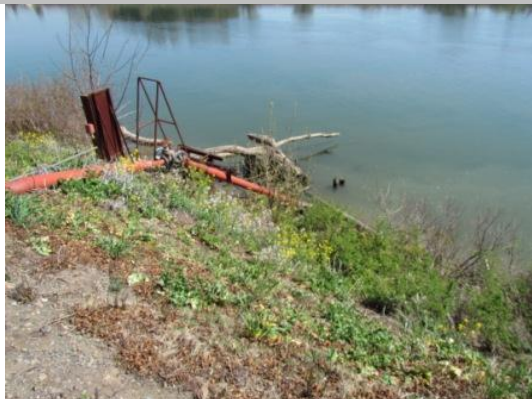
Photo 2 of 6 : FA\_2014\_RD0150\_16\_961\_20141021\_00049.jpg

LM Start	3.29	Rating **	M	Issue No.	961 (cont)	
LM End	3.29	Issue Type +	Ma	Location *	WS	
Category	Earthen Levee			GPS Latitude/Longitude		
				Start	End	
Item	Erosion / Bank Caving			38.355321 °	38.355321 °	
				-121.530902 °	-121.530902 °	
DWR ID	DWR_RD0150_02_s_2012_961					
Action/Comments						
Schedule repair of erosion site prior to the next inspection. Inspector Comments: Depressions into the waterward slope can be seen along the waterward slope at this site. Also note the damaged pump support, pump, and pipe just upstream of the site; they may contribute to the erosion in a high water event and should be removed.

View of the erosion on the waterside slope of the levee looking upstream during spring 2013 inspection.

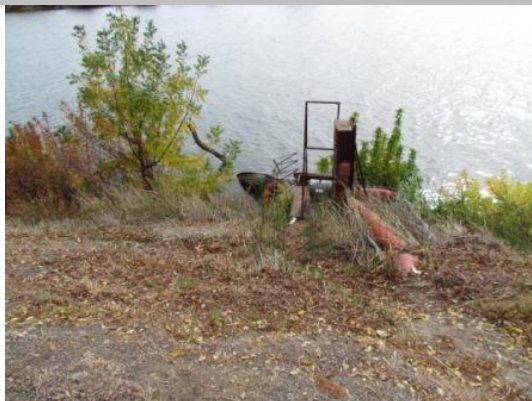
Photo 3 of 6 : FA\_2014\_RD0150\_16\_961\_20141021\_00048.jpg

View of erosion and damaged pipe and abandoned boat on the waterside of the levee looking upstream. This picture was taken during fall 2012 inspection.

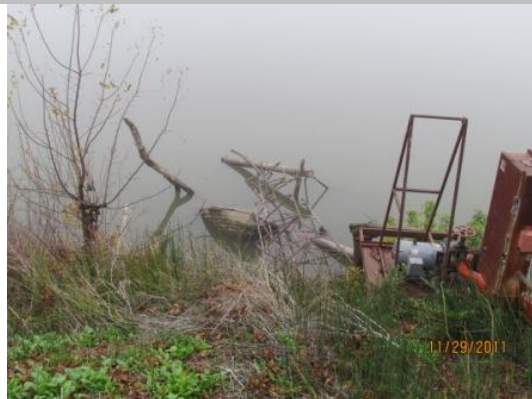
Photo 4 of 6 : FA\_2014\_RD0150\_16\_961\_20141021\_00050.jpg

LM Start	3.29	Rating **	M	Issue No.	961 (cont)	
LM End	3.29	Issue Type +	Ma	Location *	WS	
Category	Earthen Levee			GPS Latitude/Longitude		
				Start	End	
Item	Erosion / Bank Caving			38.355321 °	38.355321 °	
				-121.530902 °	-121.530902 °	
DWR ID	DWR_RD0150_02_s_2012_961					
Action/Comments						
Schedule repair of erosion site prior to the next inspection. Inspector Comments: Depressions into the waterward slope can be seen along the waterward slope at this site. Also note the damaged pump support, pump, and pipe just upstream of the site; they may contribute to the erosion in a high water event and should be removed.

View of the erosion site, and broken pump support along with a boat on the waterside of the levee. The picture was taken from the crown looking towards the toe of the levee during fall 2011 inspection.

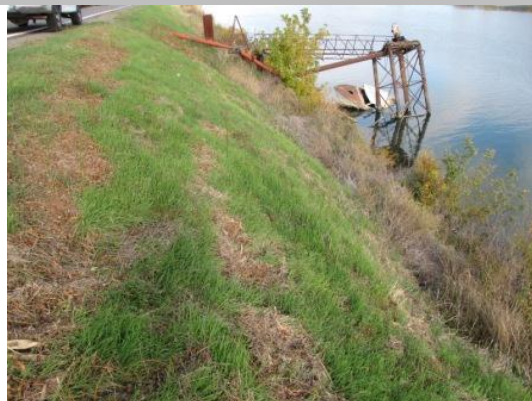
Photo 5 of 6 : FA\_2014\_RD0150\_16\_961\_20141021\_00045.jpg

View of erosion on the waterward slope looking upstream. Depressions into the slope can be seen in several places.

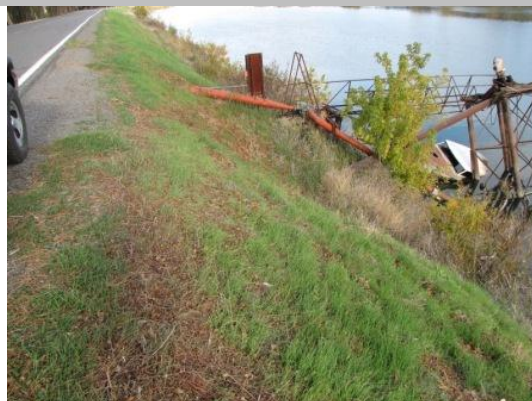
Photo 6 of 6 : FA\_2014\_RD0150\_16\_961\_20141021\_00046.jpg

LM Start	3.29	Rating **	M	Issue No.	961 (cont)	
LM End	3.29	Issue Type +	Ma	Location *	WS	
Category	Earthen Levee			GPS Latitude/Longitude		
				Start	End	
Item	Erosion / Bank Caving			38.355321 °	38.355321 °	
				-121.530902 °	-121.530902 °	
DWR ID	DWR_RD0150_02_s_2012_961					
Action/Comments						
Schedule repair of erosion site prior to the next inspection. Inspector Comments: Depressions into the waterward slope can be seen along the waterward slope at this site. Also note the damaged pump support, pump, and pipe just upstream of the site; they may contribute to the erosion in a high water event and should be removed.

Additional view of erosion on the waterward slope looking upstream.  
Note the damaged pump support, pump, and pipe just upstream of the site.

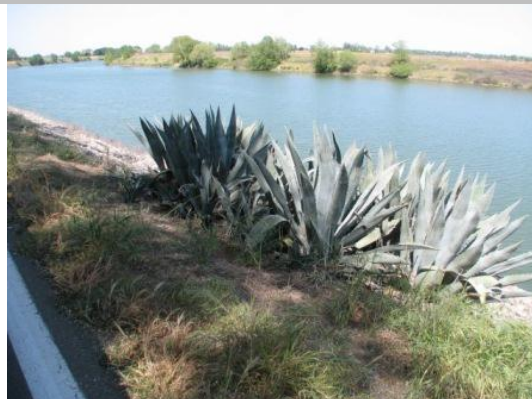
Photo 1 of 1 : FA\_2014\_RD0150\_16\_28\_20141021\_00018.jpg

Century plant on waterward slope at LM 4.76

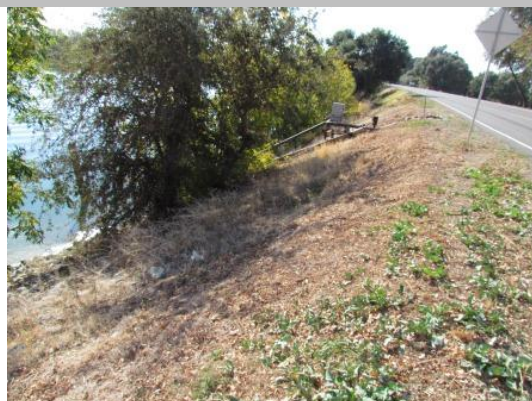
Photo 1 of 2 : FA\_2014\_RD0150\_16\_975\_20141021\_00051.jpg

LM Start	5.33	Rating **	M	Issue No.	975
LM End	5.33	Issue Type +	Ma	Location *	WS
Category	Earthen Levee			GPS Latitude/Longitude	
				Start	End
Item	Slope Stability			38.381126 °	38.381126 °
				-121.524207 °	-121.524207 °
DWR ID	DWR_RD0150_02_s_2013_975				
Action/Comments					
Repair slope instability. Inspector Comments: Depression in the landward slope at the shoulder over an irrigation pipe.

View of minor slope instability on the waterside slope of the levee looking downstream during fall 2013 inspection.

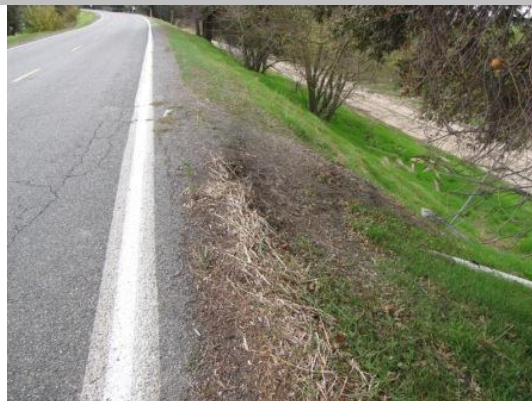
Photo 2 of 2 : FA\_2014\_RD0150\_16\_975\_20141021\_00052.jpg

View of a minor depression along the landward slope of the levee over a pipe penetration looking downstream.

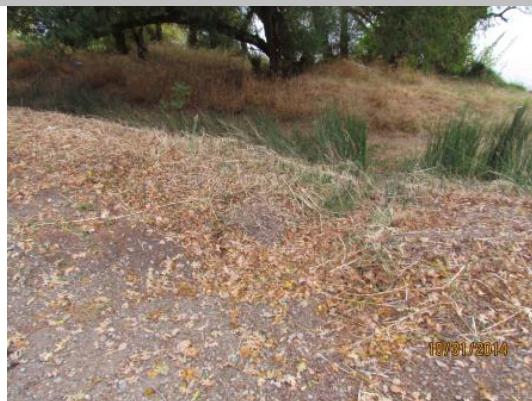
Photo 1 of 1 : FA\_2014\_RD0150\_16\_54\_20141104\_00076.jpg

LM Start	5.41	Rating **	M	Issue No.	54
LM End	5.41	Issue Type +	Ma	Location *	WS
Category	Earthen Levee			GPS Latitude/Longitude	
				Start	End
Item	Slope Stability			38.382072 °	38.382072 °
				-121.523220 °	-121.523220 °
DWR ID	DWR_RD0150_02_f_2014_54				
Action/Comments					
Repair the levee slope damaged by foot traffic and prevent access where possible.

View of a slope instability on the waterside of the levee looking towards the toe.

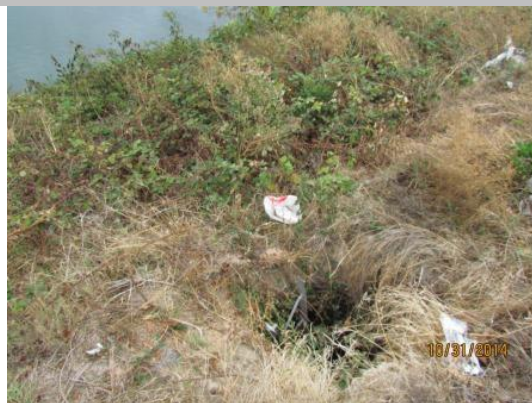
Photo 1 of 1 : FA\_2014\_RD0150\_16\_55\_20141104\_00077.jpg

An open pipe valve was found without a cover on the waterside toe of the levee.

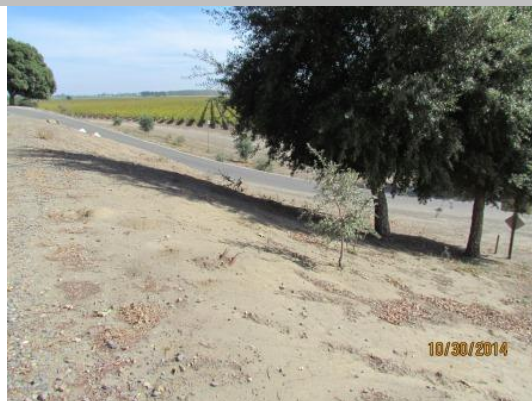
Photo 1 of 1 : FA\_2014\_RD0150\_17\_75\_20141104\_00121.jpg

LM Start	2.28	Rating **	M	Issue No.	75
LM End	2.28	Issue Type +	Ma	Location *	LS
Category	Earthen Levee			GPS Latitude/Longitude	
				Start	End
Item	Vegetation			38.353811 °	38.353811 °
				-121.565668 °	-121.565668 °
DWR ID	DWR_RD0150_03_f_2014_75				
Action/Comments					
Remove the wild growth other than native grasses from the levee slopes.					
Inspector Comments: Newly planted tree was found on the landside slope of the levee.

A few tree was planted on the landside slope of the levee looking upstream.

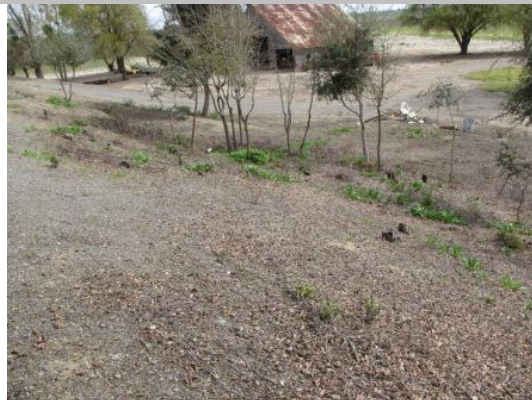
Photo 1 of 1 : FA\_2014\_RD0150\_17\_11\_20141021\_00007.jpg

View of tree stumps on the landward slope.

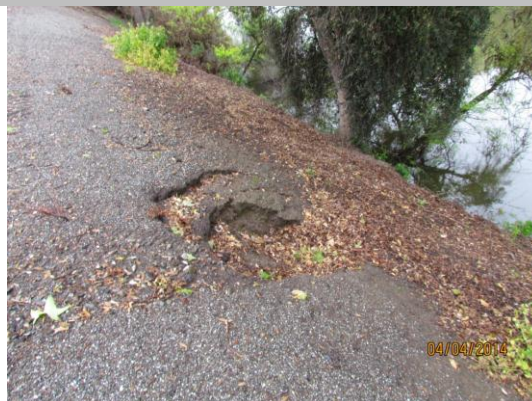
Photo 1 of 2 : FA\_2014\_RD0150\_17\_35\_20141021\_00027.jpg

LM Start	2.86	Rating **	M	Issue No.	35
LM End	2.86	Issue Type +	Ma	Location *	WS
Category	Earthen Levee			GPS Latitude/Longitude	
				Start	End
Item	Erosion / Bank Caving			38.360432 °	38.360432 °
				-121.561644 °	-121.561644 °
DWR ID	DWR_RD0150_03_s_2013_35				
Action/Comments					
Schedule repair of erosion site prior to the next inspection.

Updated picture of the erosion on the waterside slope of the levee during spring 2014 inspection.

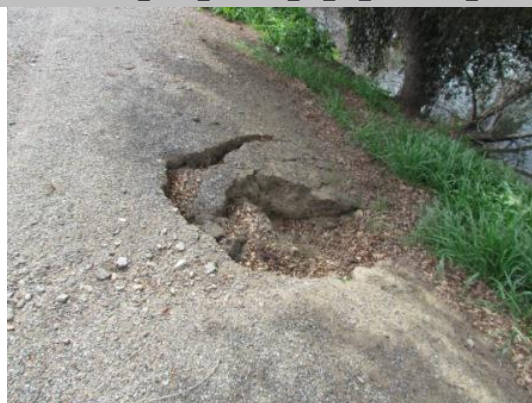
Photo 2 of 2 : FA\_2014\_RD0150\_17\_35\_20141021\_00028.jpg

Erosion was found on the waterside slope of the levee looking downstream during spring 2013 inspection.

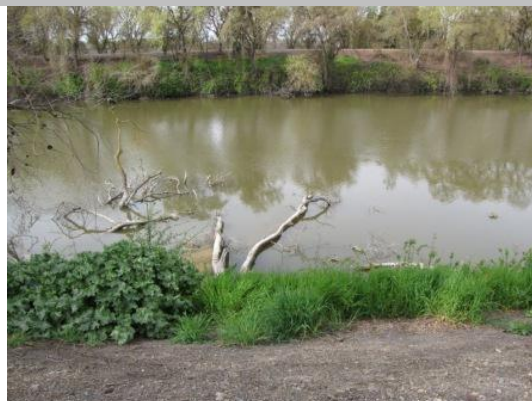
Photo 1 of 1 : FA\_2014\_RD0150\_17\_17\_20141021\_00014.jpg

View of tree stumps on the waterward slope.

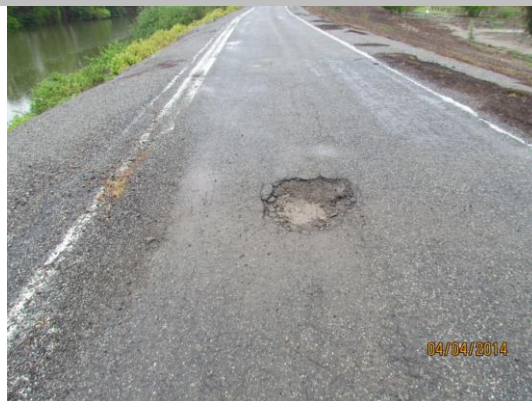
Photo 1 of 1 : FA\_2014\_RD0150\_17\_72\_20141021\_00074.jpg

A crown depression was found looking upstream.

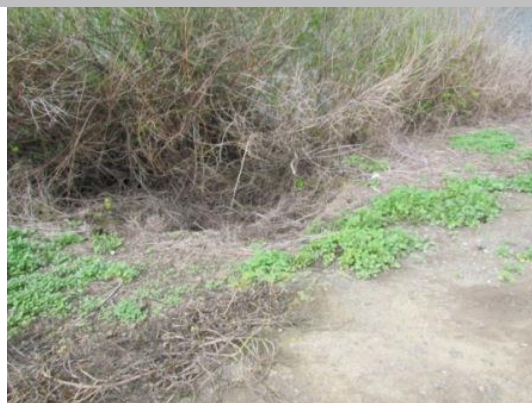
Photo 1 of 2 : FA\_2014\_RD0150\_17\_76\_20141021\_00076.jpg

LM Start	2.93	Rating **	M	Issue No.	76
LM End	2.93	Issue Type +	Ma	Location *	WS
Category	Earthen Levee			GPS Latitude/Longitude	
				Start	End
Item	Slope Stability			38.361375 °	38.361375 °
				-121.562134 °	-121.562134 °
DWR ID	DWR_RD0150_03_s_2012_76				
Action/Comments					
Repair slope instability.

Erosion was found on the waterside of the levee looking upstream. This picture was taken during spring 2012 inspection.

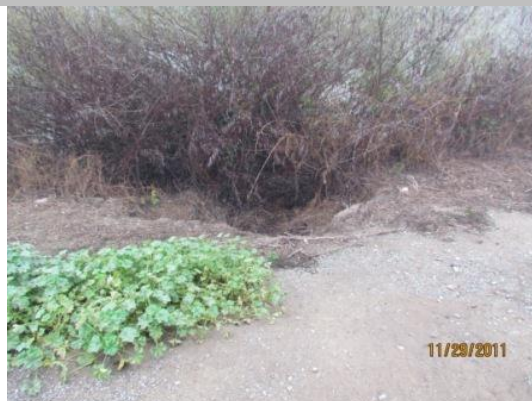
Photo 2 of 2 : FA\_2014\_RD0150\_17\_76\_20141021\_00077.jpg

Slope instability was found on the waterside of the levee. The picture was taken from the crown looking towards the toe of the levee.

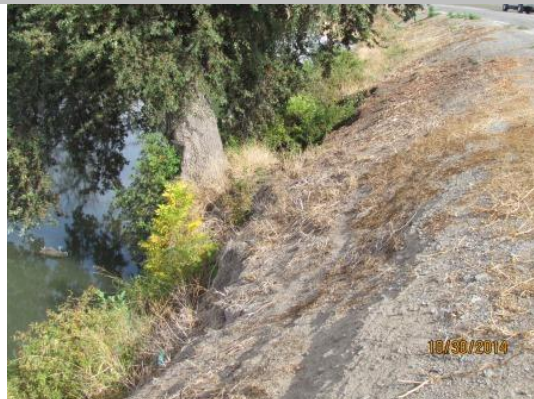
Photo 1 of 2 : FA\_2014\_RD0150\_17\_40\_20141104\_00124.jpg

LM Start	3.37	Rating **	M	Issue No.	40
LM End	3.37	Issue Type +	Ma	Location *	WS
Category	Earthen Levee			GPS Latitude/Longitude	
				Start	End
Item	Erosion / Bank Caving			38.363008 °	38.363008 °
				-121.556751 °	-121.556751 °
DWR ID	DWR_RD0150_03_s_2013_40				
Action/Comments					
Schedule repair of erosion site prior to the next inspection.

Updated picture of the erosion on the waterside of the levee looking upstream during fall 2014 inspection.

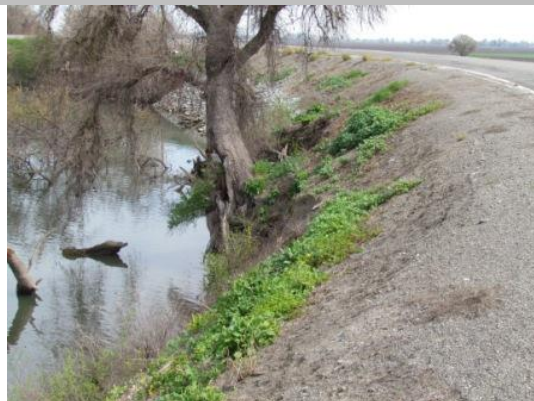
Photo 2 of 2 : FA\_2014\_RD0150\_17\_40\_20141021\_00032.jpg

Erosion was found on the waterside toe of the levee looking upstream during spring 2013 inspection.

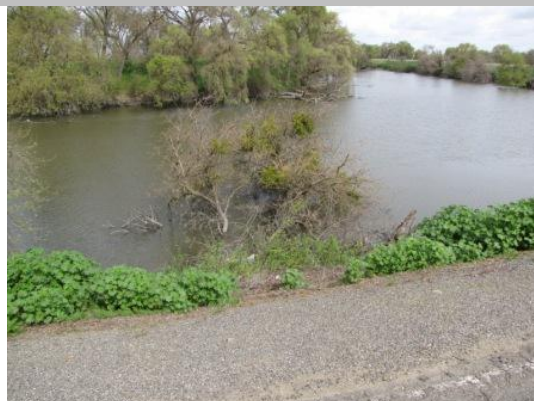
Photo 1 of 1 : FA\_2014\_RD0150\_17\_27\_20141021\_00019.jpg

View of tree stumps on the waterside slope looking upstream.

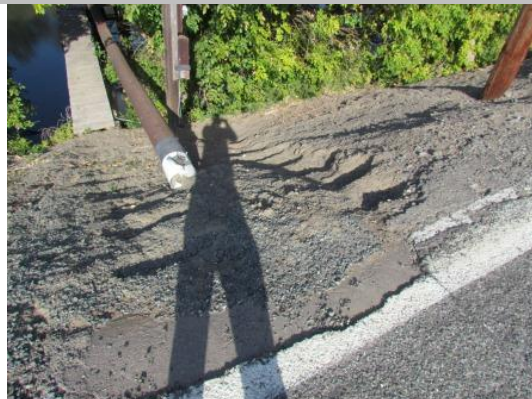
Photo 1 of 1 : FA\_2014\_RD0150\_17\_114\_20141021\_00093.jpg

View of steps that were dug on the waterside slope of the levee looking upstream.

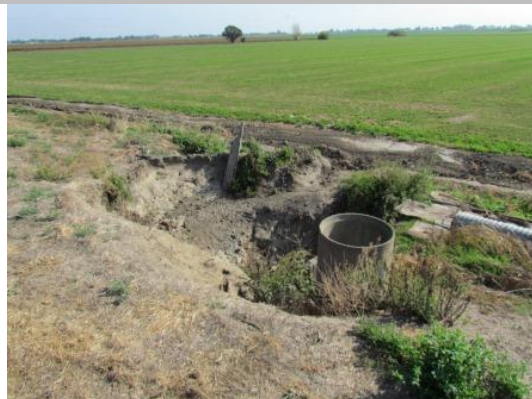
Photo 1 of 1 : FA\_2014\_RD0150\_17\_115\_20141021\_00094.jpg

LM Start	3.45	Rating **	U	Issue No.	115
LM End	3.45	Issue Type +	Ma	Location *	LS
Category	Earthen Levee			GPS Latitude/Longitude	
				Start	End
Item	Erosion / Bank Caving			38.363540 °	38.363540 °
				-121.555554 °	-121.555554 °
DWR ID	DWR_RD0150_03_f_2013_115				
Action/Comments					
Schedule repair of erosion site prior to the next inspection.					
Inspector Comments: Erosion was found on the landside toe of the levee.

A drainage ditch with depth of 4 feet and width of 15 feet was found on the landside toe of the levee. The picture was taken from the landside slope looking upstream during the fall 2013 inspection.

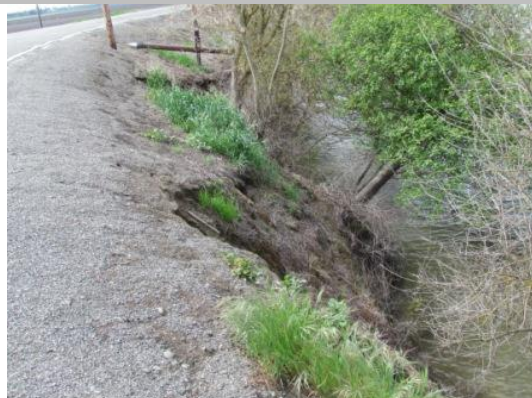
Photo 1 of 1 : FA\_2014\_RD0150\_17\_98\_20141021\_00092.jpg

Erosion was found on the waterside of the levee looking downstream.

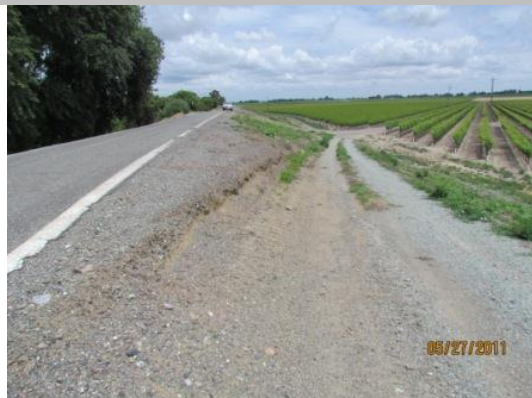
Photo 1 of 2 : FA\_2014\_RD0150\_17\_927\_20141021\_00097.jpg

LM Start	3.75	Rating **	A/W	Issue No.	927
LM End	3.75	Issue Type +	Ma	Location *	LS
Category	Earthen Levee			GPS Latitude/Longitude	
				Start	End
Item	Slope Stability			38.367305 °	38.367305 °
				-121.554984 °	-121.554984 °
DWR ID	DWR_RD0150_03_s_2012_927				
Action/Comments					
Repair the levee slope damaged by vehicle traffic and prevent access where possible.

Slope instability possible due to vehicular traffic on the landside of the levee. The picture was taken from the crown looking upstream during Spring 2011 inspection.

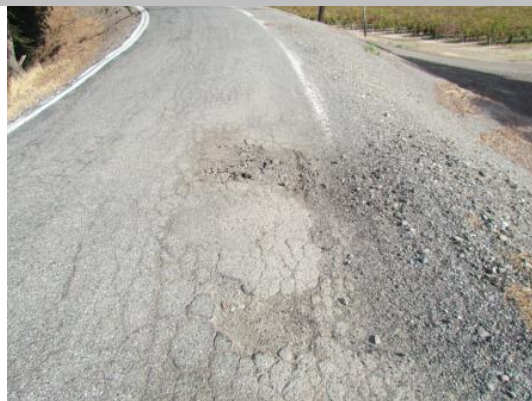
Photo 1 of 1 : FA\_2014\_RD0150\_17\_117\_20141021\_00095.jpg

Crown depression was found looking upstream during the fall 2013 inspection.

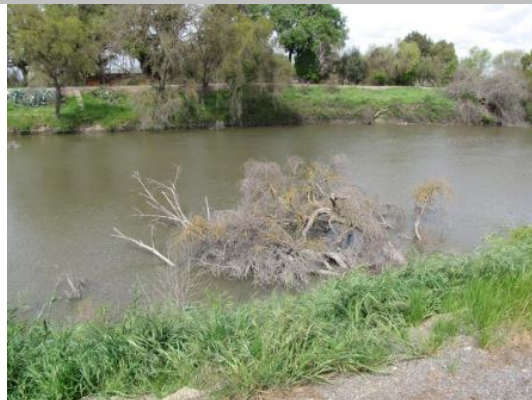
Photo 1 of 1 : FA\_2014\_RD0150\_17\_37\_20141021\_00030.jpg

View of tree stumps on the waterward slope.

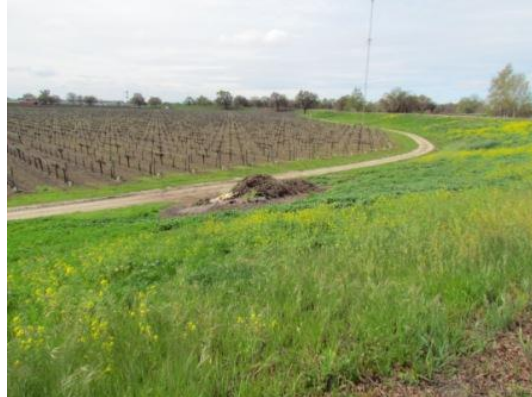
Photo 2 of 4 : FA\_2014\_RD0150\_17\_51\_20141021\_00044.jpg

Prunings were found on the landside of the levee looking downstream.

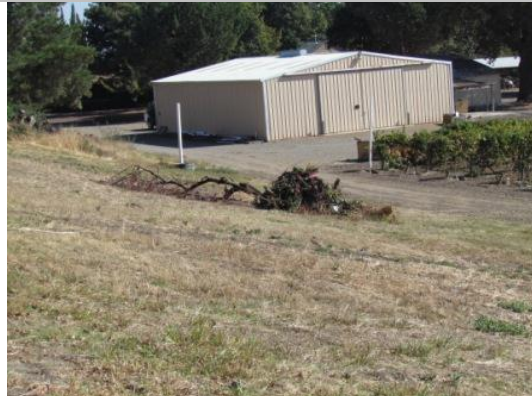
Photo 3 of 4 : FA\_2014\_RD0150\_17\_51\_20141021\_00045.jpg

Prunings were found on the landside of the levee looking upstream. This picture was taken during fall 2012 inspection.

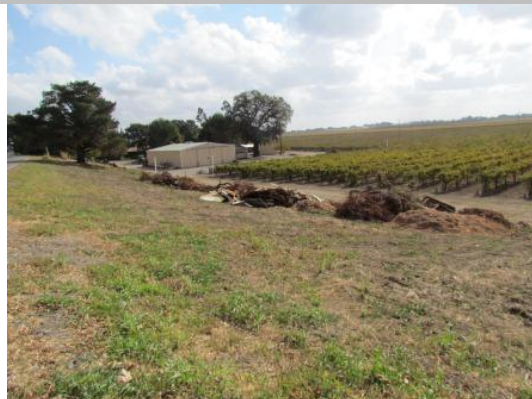
Photo 4 of 4 : FA\_2014\_RD0150\_17\_51\_20141021\_00046.jpg

Updated picture of the pruning pile on the landside of the levee looking upstream during the fall 2013 inspection.

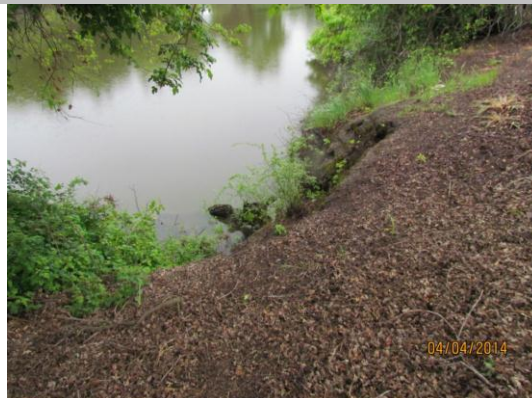
Photo 1 of 1 : FA\_2014\_RD0150\_17\_80\_20141021\_00083.jpg

View of an erosion site on the waterside toe of the levee looking upstream.

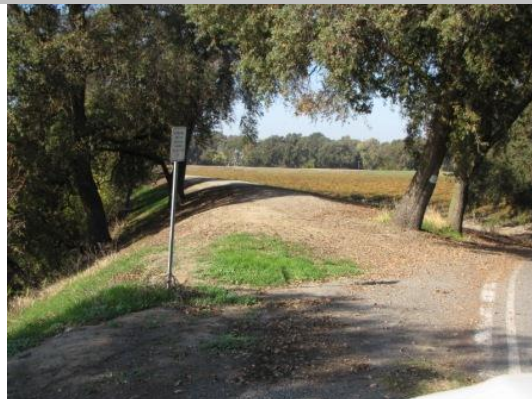
Photo 1 of 1 : FA\_2014\_RD0150\_17\_941\_20141021\_00105.jpg

View of varying elevations in the crown of the levee at the transition from county road to access road.

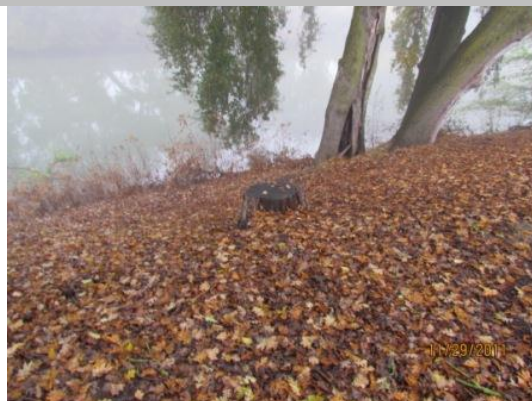
Photo 1 of 1 : FA\_2014\_RD0150\_17\_68\_20141021\_00069.jpg

Tree stump was found on the waterside of the levee looking upstream.

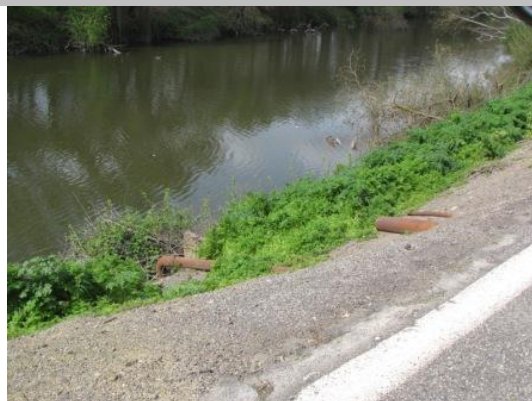
Photo 1 of 1 : FA\_2014\_RD0150\_17\_46\_20141021\_00035.jpg

View of an improperly abandoned pipe through the levee looking upstream.

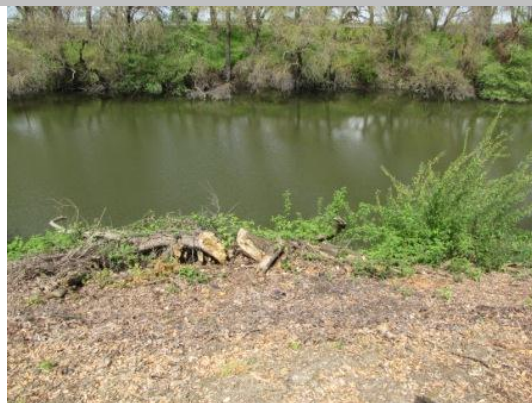
Photo 1 of 1 : FA\_2014\_RD0150\_17\_49\_20141021\_00040.jpg

View of tree stumps on the waterward slope.

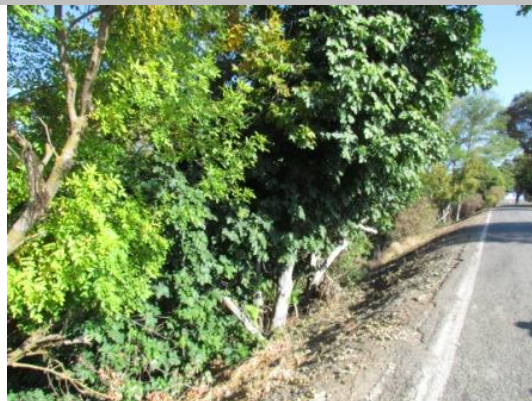
Photo 1 of 2 : FA\_2014\_RD0150\_17\_62\_20141021\_00059.jpg

Tree was blocking the visibility on the waterside of the levee looking upstream. This picture was taken during fall 2012 inspection.

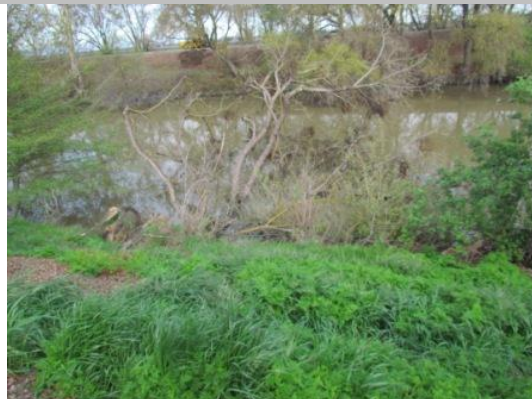
Photo 2 of 2 : FA\_2014\_RD0150\_17\_62\_20141021\_00060.jpg

Vegetation on the waterside of the levee looking downstream.

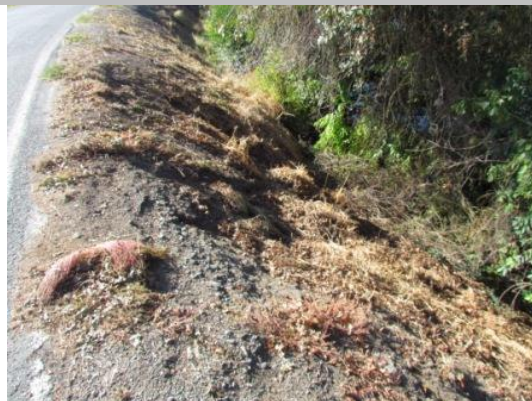
Photo 1 of 1 : FA\_2014\_RD0150\_17\_43\_20141021\_00033.jpg

Slope instability was found on the waterside of the levee looking downstream.

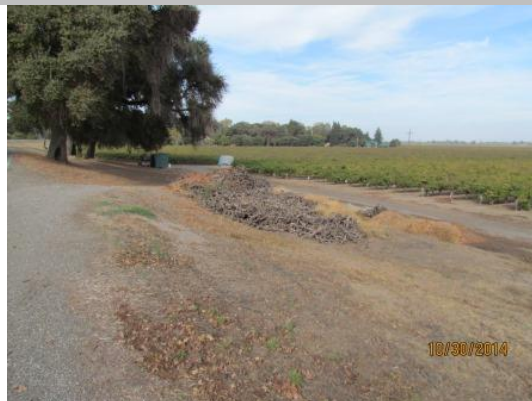
Photo 1 of 1 : FA\_2014\_RD0150\_17\_83\_20141104\_00126.jpg

Prunings were found on the landside toe of the levee looking upstream.

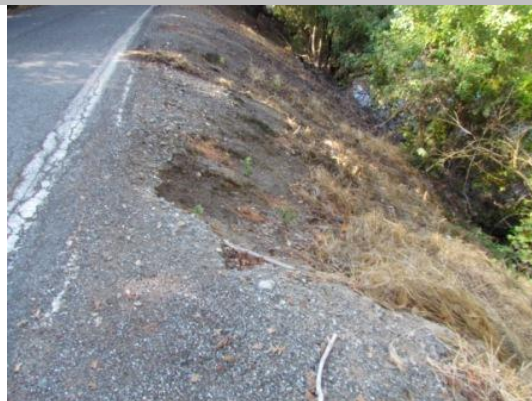
Photo 1 of 4 : FA\_2014\_RD0150\_17\_61\_20141021\_00056.jpg

Erosion was found on the waterside slope of the levee looking downstream. This updated picture was taken during fall 2012 inspection.

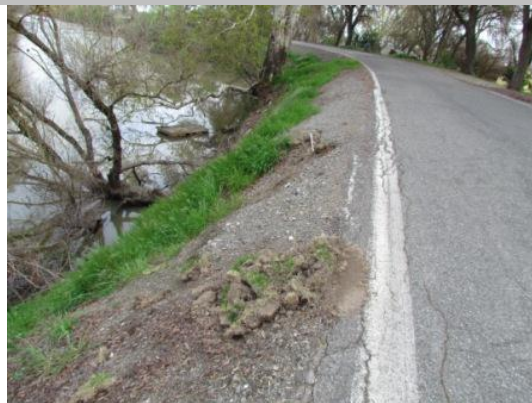
Photo 2 of 4 : FA\_2014\_RD0150\_17\_61\_20141021\_00057.jpg

Erosion on the waterside of the levee looking upstream. This picture was taken during spring 2012 inspection.

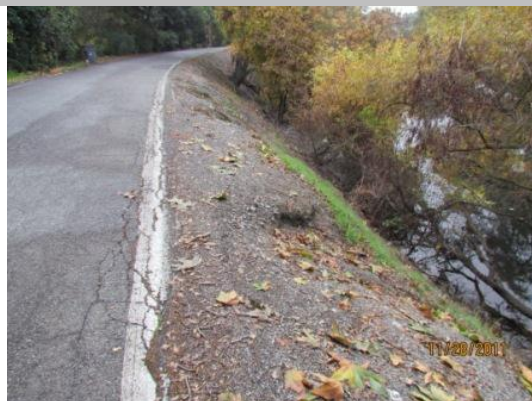
Photo 3 of 4 : FA\_2014\_RD0150\_17\_61\_20141021\_00058.jpg

Erosion was found on the waterside of the levee looking downstream.  
This picture was taken during fall 2011 inspection.

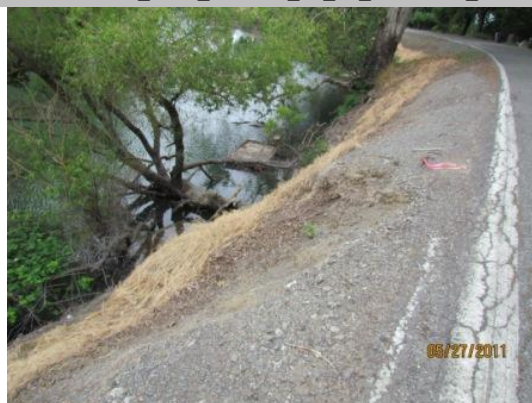
Photo 4 of 4 : FA\_2014\_RD0150\_17\_61\_20141021\_00055.jpg

Updated erosion site picture on the waterside slope of the levee looking upstream during spring 2011 inspection.

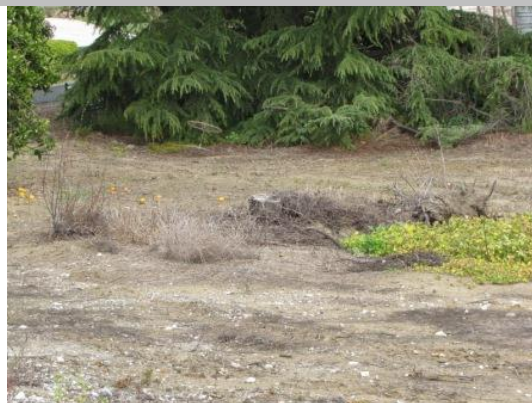
Photo 1 of 1 : FA\_2014\_RD0150\_17\_63\_20141021\_00061.jpg

View of a tree stump on the landward slope.

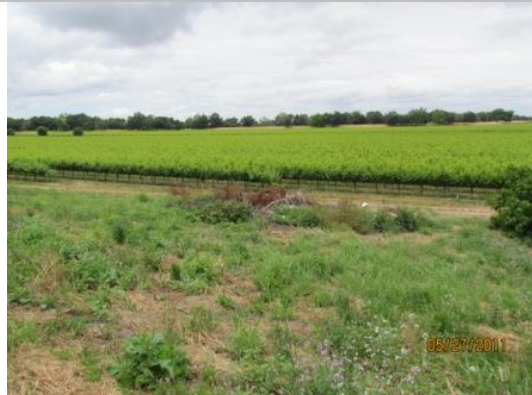
Photo 1 of 3 : FA\_2014\_RD0150\_17\_935\_20141021\_00101.jpg

Prunings located on the toe of landward side of the levee. The picture was taken from the crown looking upstream.

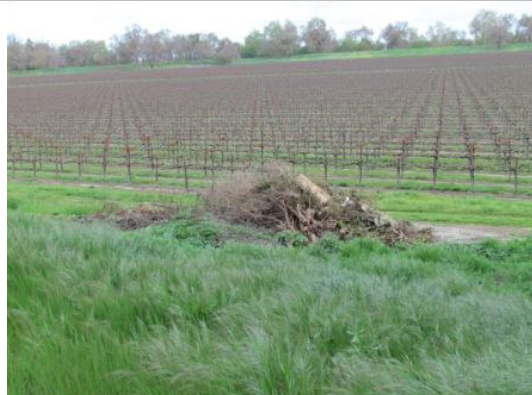
Photo 2 of 3 : FA\_2014\_RD0150\_17\_935\_20141021\_00102.jpg

Prunings were found on the landside of the levee looking upstream.

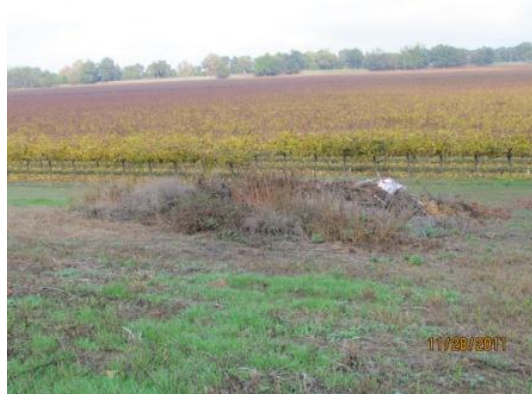
Photo 3 of 3 : FA\_2014\_RD0150\_17\_935\_20141021\_00103.jpg

Prunings were found on the landside of the levee looking upstream. This picture was taken during fall 2011 inspection.

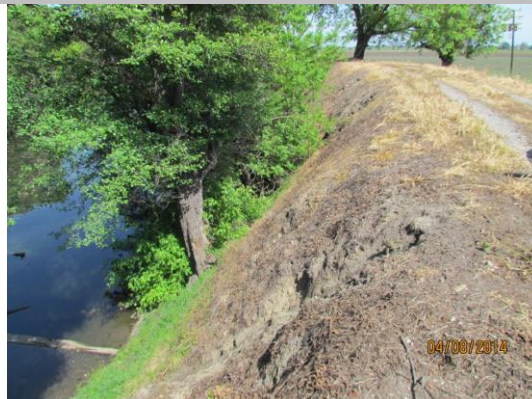
Photo 1 of 3 : FA\_2014\_RD0150\_17\_67\_20141021\_00066.jpg

Updated picture of the slope instability on the waterside shoulder looking upstream during spring 2014 inspection.

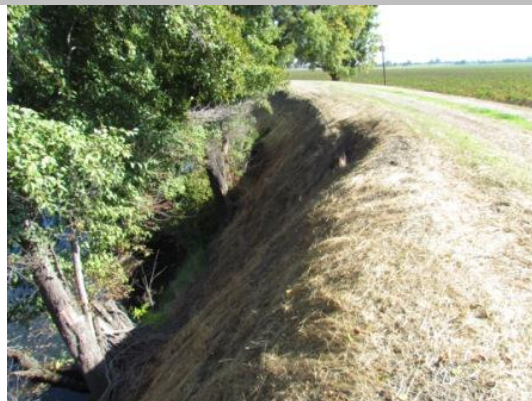
Photo 2 of 3 : FA\_2014\_RD0150\_17\_67\_20141021\_00067.jpg

Slope instability was found on the waterside shoulder of the levee looking upstream. This picture was taken during fall 2012 inspection.

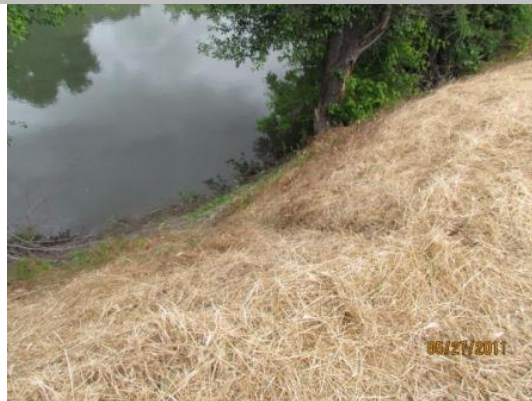
Photo 3 of 3 : FA\_2014\_RD0150\_17\_67\_20141021\_00068.jpg

Slope instability on the waterside slope of the levee. The picture was taken from the crown looking upstream.

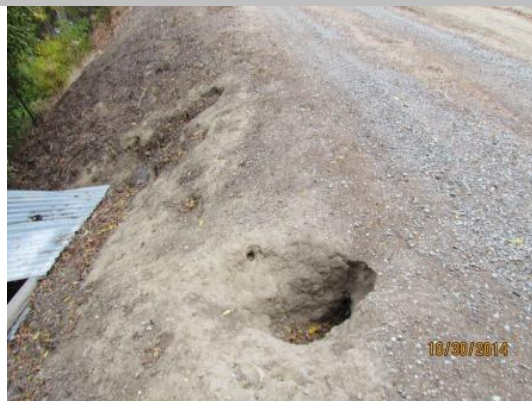
Photo 1 of 2 : FA\_2014\_RD0150\_17\_89\_20141104\_00128.jpg

Updated picture of a rodent hole on the waterside shoulder of the levee during fall 2014 inspection.

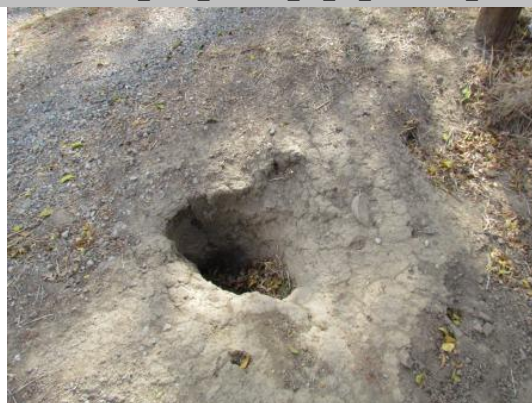
Photo 2 of 2 : FA\_2014\_RD0150\_17\_89\_20141021\_00086.jpg

View of the rodent hole on the waterside shoulder of the levee looking downstream during the fall 2013 inspection.
